Fire Investigation Report

Investigation No.: 252-034-2018

Fire Cause: Accidental - Electrical Failure

Property Type: Multi-Unit Dwelling - Over 12 Units

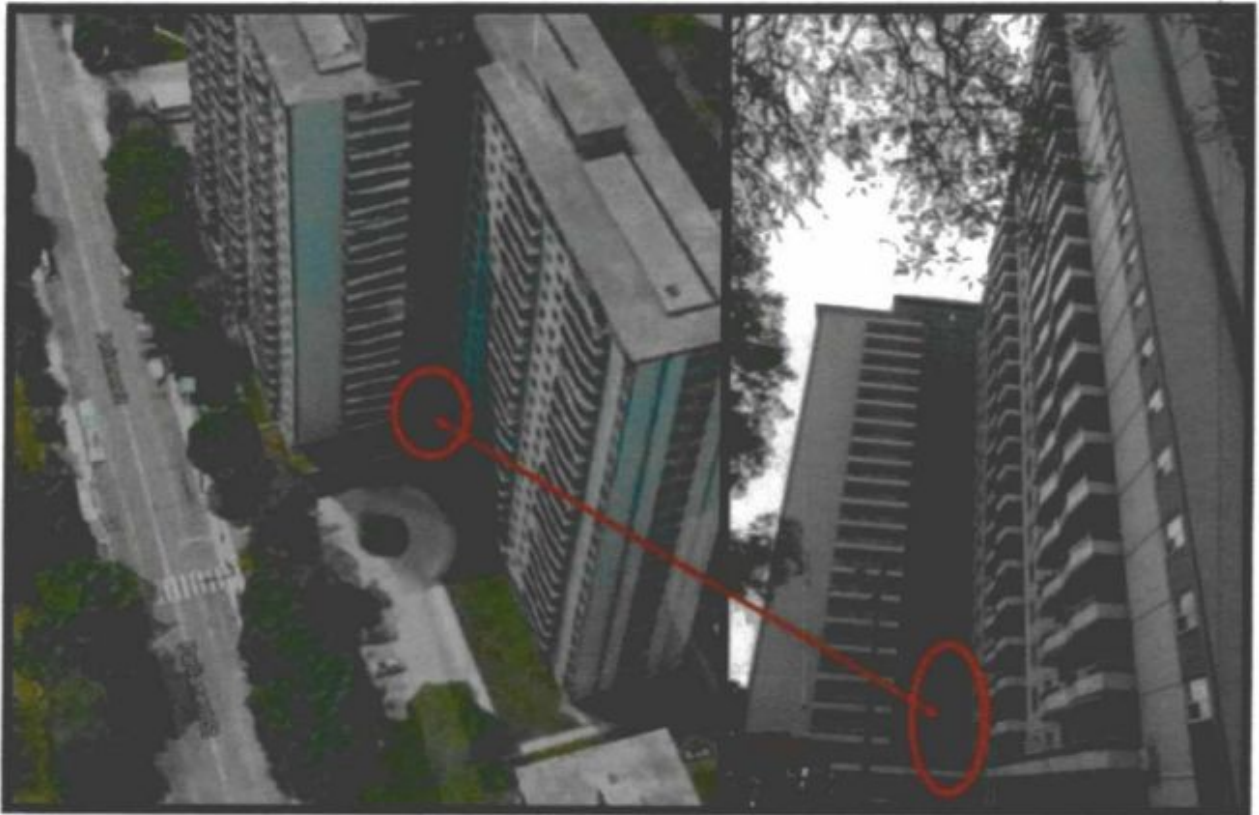
The exterior of the building was examined prior to entering the building. The exterior of the building did not present fire damage to the front (east), north, west and south elevations. The lack of exterior fire patterns or significant smoke spread indicate an interior fire origin.

Photo # 2 (East Facing Side) -- North and South Apartment Complex Units (Right Photo -- Main Entrance) -- Right Photo: Jpg # 1766

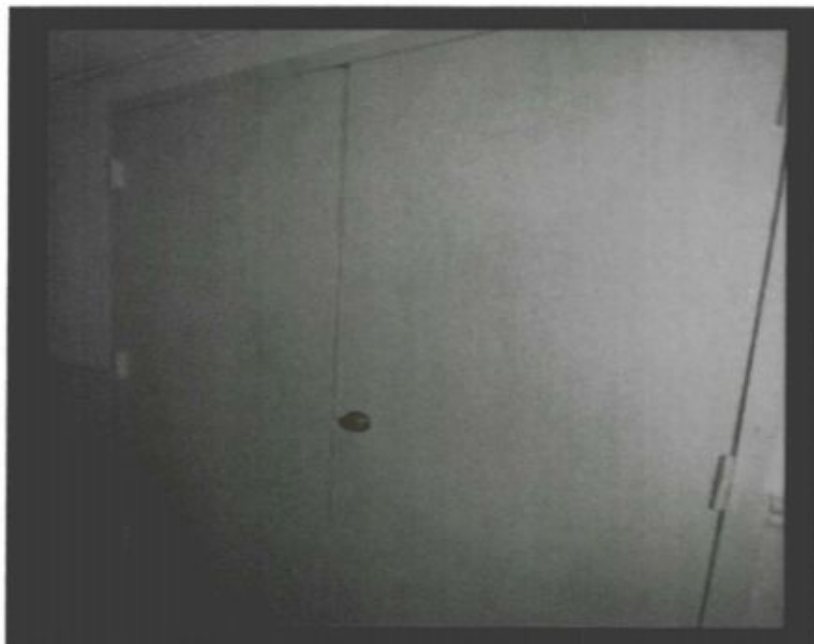
The electrical closets located on the south end of the hallway measured (L) 82" x (W) 43" x (H) 96". These closets were secured by deadbolts and fire safety double doors. The interior spaces were constructed of concrete within their interiors with plywood cladding along the west, north and south walls. The main circuits from the switch cabinet in the basement was routed along the west wall extending vertically to the floors above. Heat detectors were affixed to the ceilings within each cabinet unit.

Photo # 3 -- Exemplar Electrical Cabinets Within Apartment Floors -- Jmg # 1867

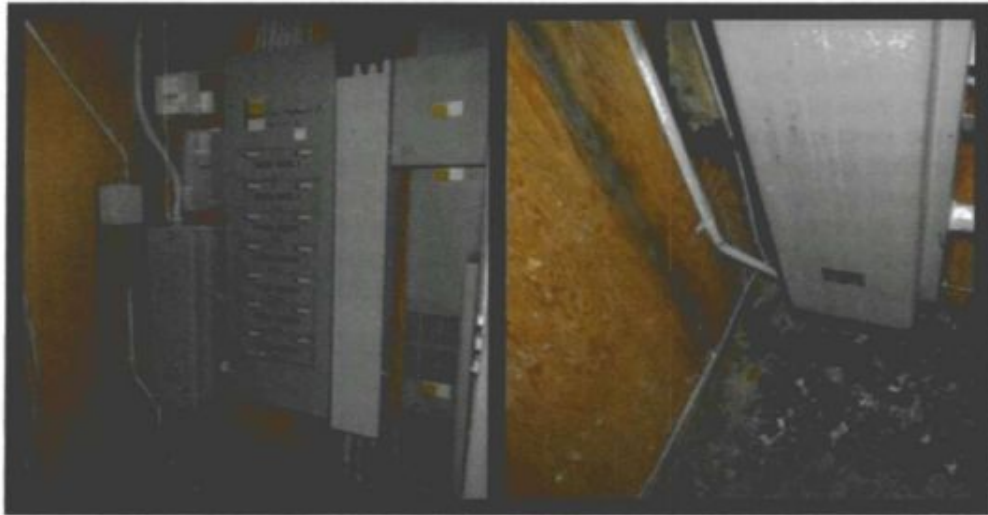
Floors 1 to 5 – Fire damage was limited on these floors with partial consumption and charring occurring to the plywood wall cladding within the cabinets on floors four and five. The cabinet on floor five had charring and partial consumption to the plywood paneling in the southwest corner. This fire pattern extended from a confined vertical channel behind the plywood from floor to the ceiling.

Photo # 4 – Electrical Cabinet on Floor Four – Charring to Plywood paneling "img # 1817/1822

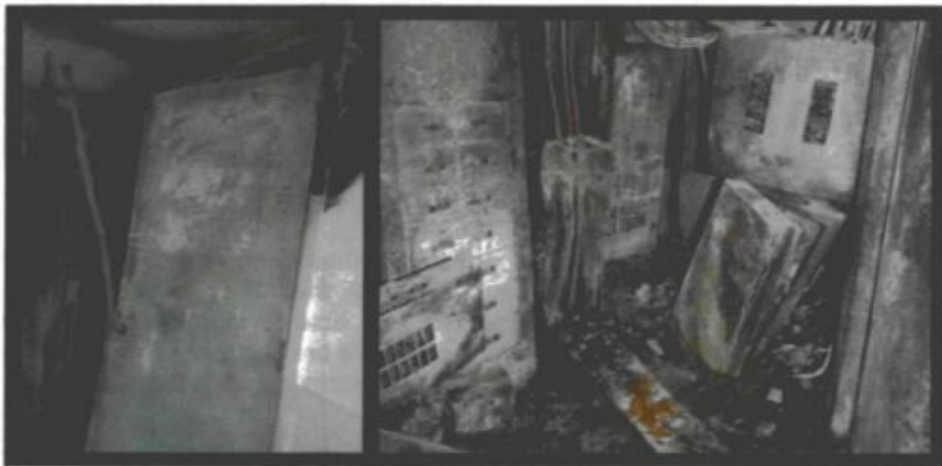
Floors 6 to 14 – There was severe fire damage and evidence of arcing in these sets of closets including consumption of the plywood wall coverings lining the closets, paint consumption, charring and oxidation to the metal circuit channels. The paint on the fire doors on these floors was charred with sections of paint partially consumed on their surface areas. Fire patterns within these cabinets were a result of conductive and radiant heat transfer from the overheating electrical circuits routed through the wall cavity.

Photo # 5 – Electrical Cabinet on Floor Seven – Paint Consumption and Oxidation to Metal Surfaces *jpg # 1852/1857

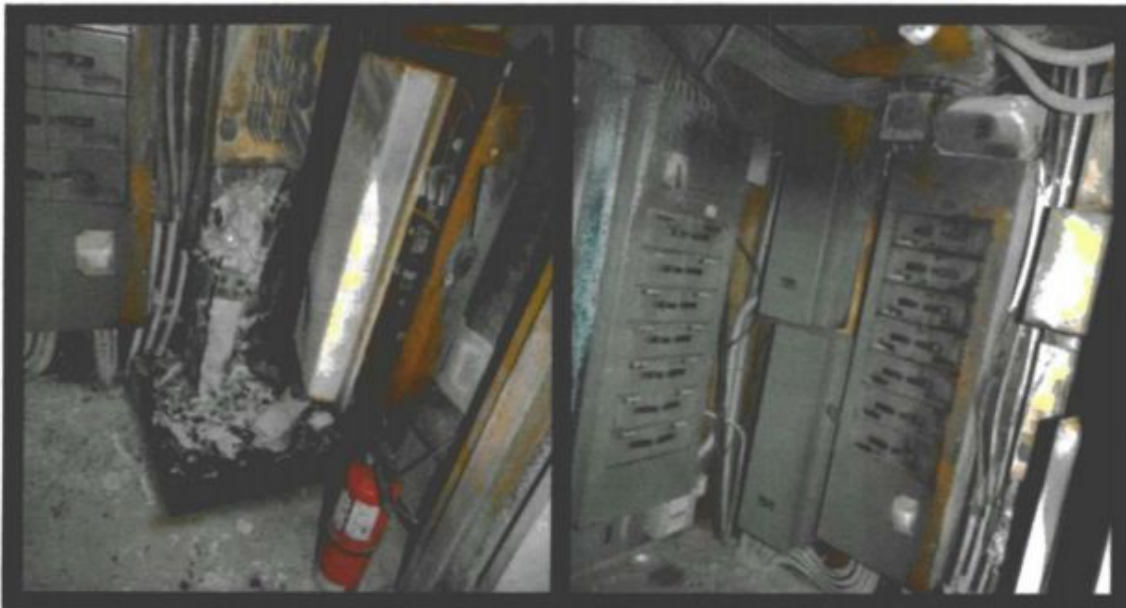
Floor 15 – There was severe damage to the heating buss duct with melting and solidifying of the aluminum, resulting in a large deposit of pooled aluminum at the bottom of the buss duct baseplate within the electrical cabinet. The plywood wall covering lining the closets remained intact with paint consumption occurring to the metal cabinets and fixtures. Charring to other painted surfaces was predominant on elevated cabinets and fixtures at ceiling height while oxidation occurred to the exposed metal circuit channels. The paint on the fire doors on this floor was charred with sections of paint partially consumed on their surface areas. Fire patterns within these cabinets were a result of conductive and radiant heat transfer from the main electrical circuits routed through the duct work.

Photo # 6 – Electrical Cabinet on Floor Fifteen – Melted Aluminum and Oxidation to Metal Surfaces *jpg # 2008/2007

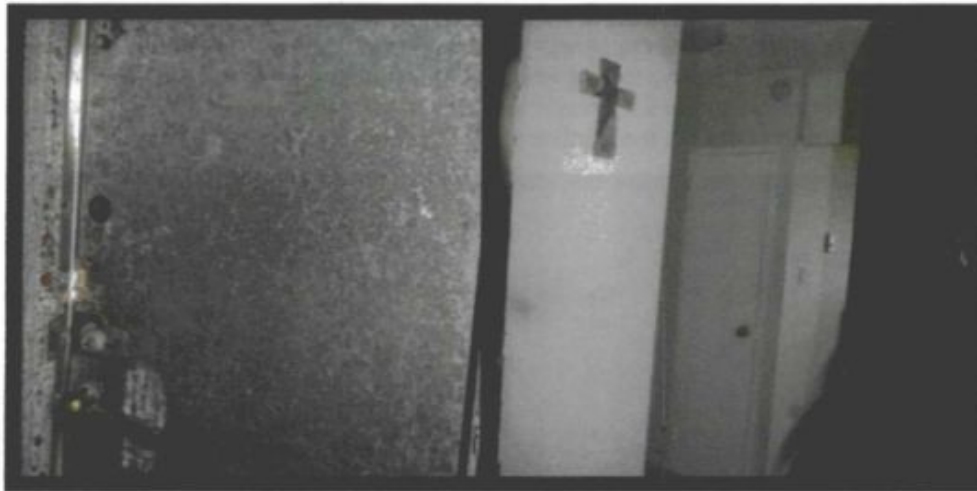
Apartments # 1512 and # 1514 had fire patterns to their interiors due to smoke migration from the electrical closet at the end of the hallway. Once the thermal layer from the cabinet impacted the doorways in the corner of the hallway, smoke was able to migrate into the entry ways of these apartments from gaps along and to the sides of the fire break doors. Smoke that penetrated through these gaps allowed for products of incomplete combustion to cool within and on the interior walls.

Photo # 6 - Radiant Heat Exposure to Apartment Unit # 1514 (Interior Unaffected) *log # 2017/2018

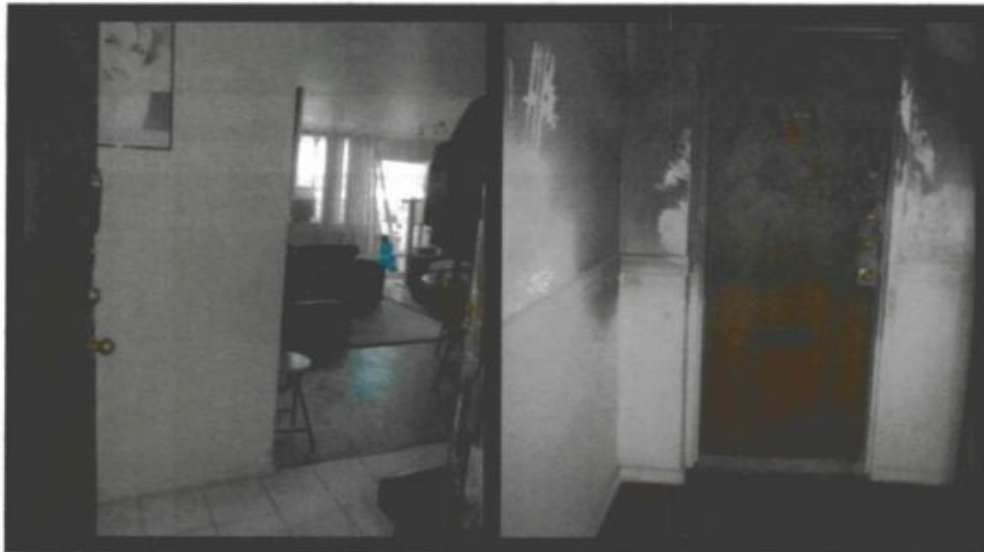
Photo # 7 - Radiant Heat Exposure to Apartment Unit # 1512 (Interior Unaffected) *log # 2026/2027

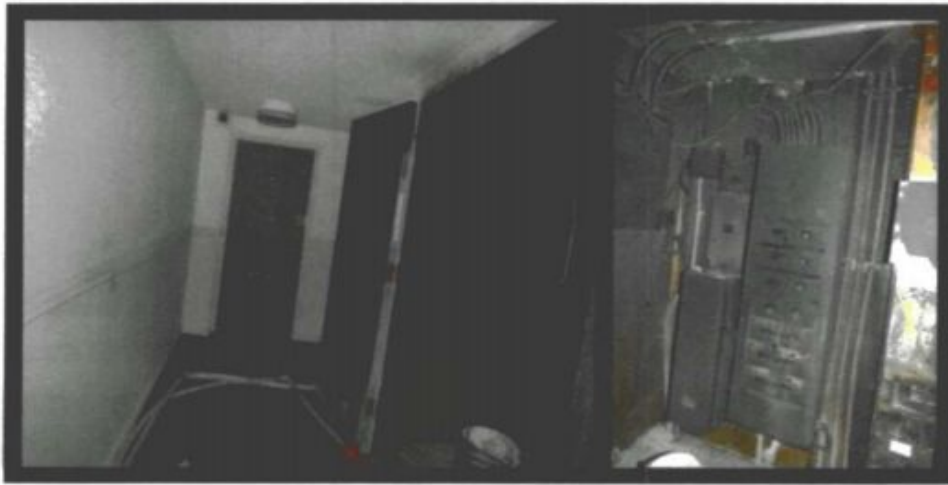
Floors 16 to 22 – There was less of a degree of fire spread to these upper floors. Soot and charring occurred to the plywood wall cladding. Charring to painted surfaces was predominant on elevated cabinets and fixtures at ceiling height while oxidation occurred to the exposed metal circuit channels. The fire patterns within these electrical closets on floors 16 through 22 was a result of smoke spread from below migrating through the confined wall cavities and conduit channels.

Photo # 8 – Electrical Cabinet on Floor Sixteen – Soot on Interior Surfaces/Charring to Plywood at South Log # 2034/2035

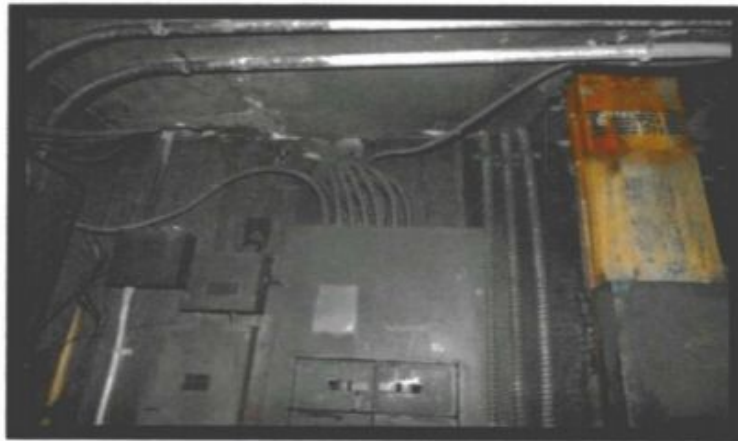
Photo # 9 – Electrical Cabinet on Floor Sixteen – Soot on Interior Surfaces/Oxidation to Channel Duct Log # 2040

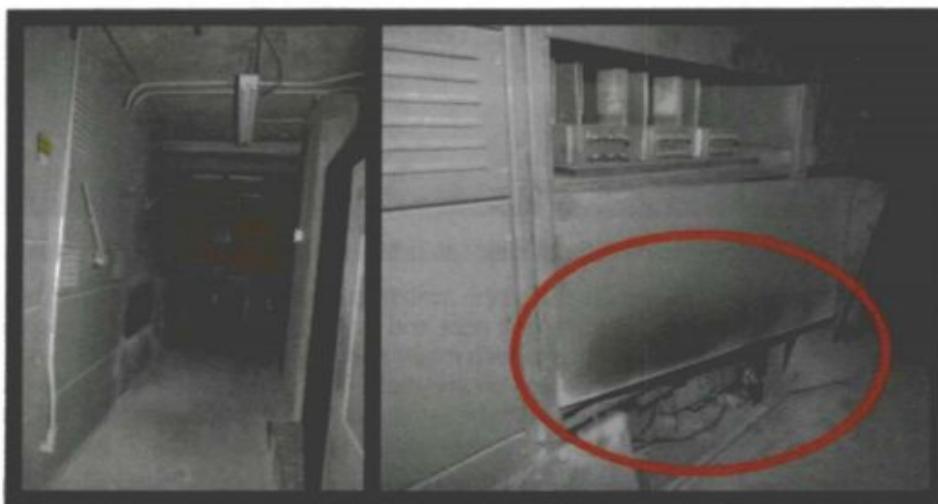
Basement - The basement was examined, with fire pattern physical evidence isolated and contained within the electrical room in the east side of the building. Within the electrical room, fire damage was visible to the outsides of the switchgear cabinets. A soot layer was evident on all the equipment within this room. The main service cables entering the building from the outside vault entered through the east wall into a caged and secured room behind the switchgear cabinets.

Photo # 10 – Entrance to Electrical Room in Basement/Fire Pattern on Switchgear Cabinet - Jimg # 1794/2141

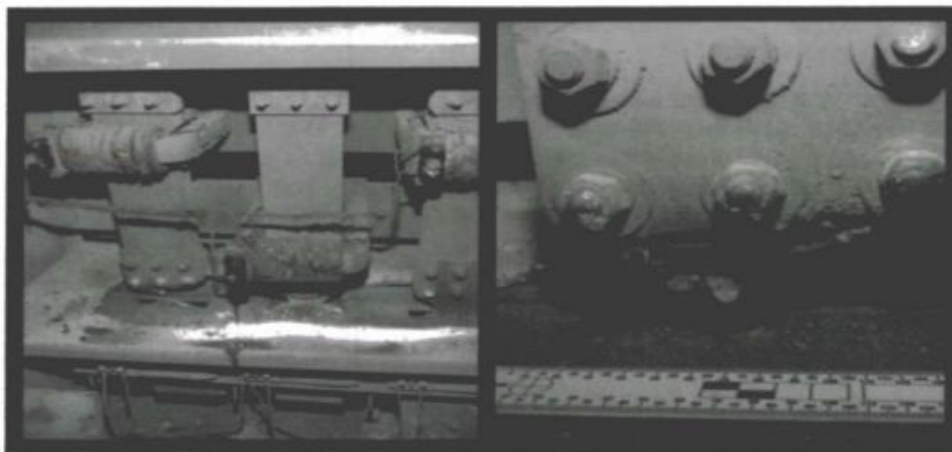
Switchgear cabinets had the doors pushed out slightly. Within, several banks of equipment had damage to the switchgear and/or had water pooled inside. The three main input fuses were physically intact. Subsequent testing confirmed that one had operated (tripped). The switchgear for the main service feed from the transformers was severely damaged, with evidence of arcing, and one of the service legs after the main fuses was damaged and consumed.

Photo # 11 – Main Service Leg within Switchgear Cabinet / Close Up of Damaged Switchgear Link .jpg # 21432165

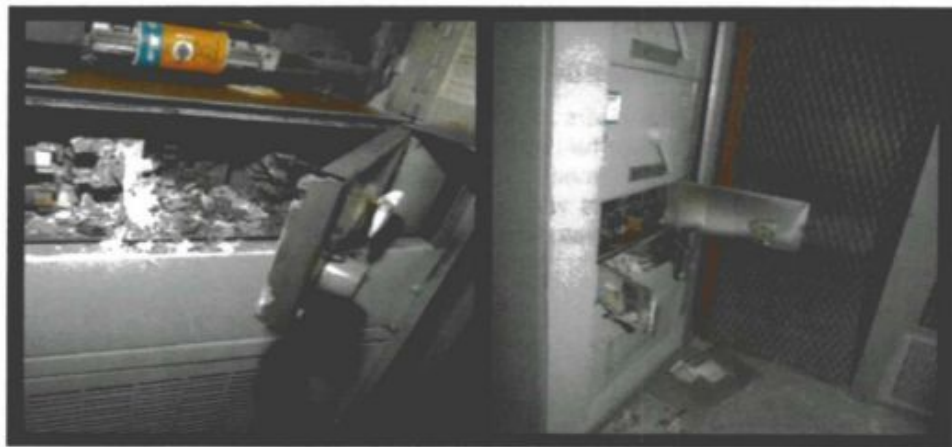
A vertical rack cabinet at the south end of the switchgear had four damaged shelves, each with doors, for switches and fuses. The top shelf had soot and burning evident to the components. The second shelf down contained undamaged fuses with minor soot deposits. The third shelf contained fuses with approximately a half inch of water pooled on the shelf. The bottom shelf had severe arcing evident and damaged shut off switches. In the northern most cabinet of the switchgear the ground cable had evidence of severe arcing with a portion consumed within the cabinet.

Photo # 12 – Switch/Fuse Cabinet south of Switchgear Cabinet - Close Up of Damaged Switches .jpg # 21432144
